The Acoustical Performance Analysis of Bilkent Amphitheater: Proposal for Acoustical Renovation

The 4000 seat multi-purpose Bilkent Amphitheater is a semi-closed amphitheater with a volume of 90,000 m³, designed to serve the University's and the city's educational and artistic activities. At the beginning, the amphitheater was designed only for open-air performances. Afterwards it was decided it would be roofed with a tensile membrane in order to protect the spectators from atmospheric effects. However, the covered amphitheater was turned into a resounding and a problematic place with a reverberation time of more than 6 s. when the hall is unoccupied. Acoustical interventions were implemented, but these have not been sufficient in decreasing the number of problematic echoes and dead spots. This paper analyzes the hall by means of assessing the fundamental acoustical parameters for both speech and music. Parameters such as reverberation time, early decay time, clarity, definition, lateral fraction, strength and speech transmission index were calculated by the aid of ODEON Room Acoustics Program simulation software Version 6.01. It was observed that most of the parameters are out of

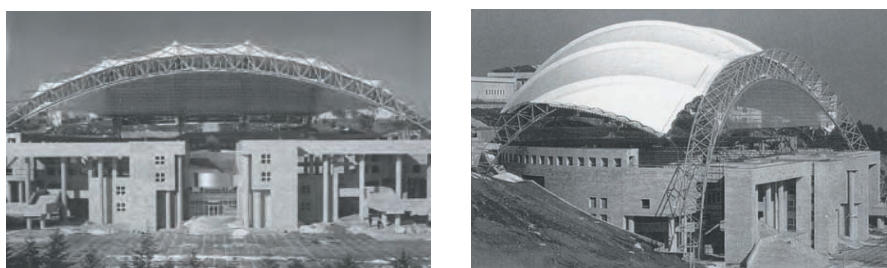
Figure 1: Exterior views from Bilkent Amphitheater.

Similar to those Roman theaters of the Antiquity, the Bilkent Amphitheater has in plan a semicircular shape [7, 8]. It has a radius of 48 meters corresponding nearly 100 meters in diameter and 18 meter height approximately from the stage to the top of the main arcade at the back of the seating area (Figure 1 and 2). The amphitheater is built in reinforced concrete and all surfaces of the walls and staircases are clad with travertine plates. The front and inner face of main arcade at the back of the seating area is smooth unpainted concrete. The columns of this area are also clad with travertine, which are stripped vertically. The stage is partially covered with travertine, whereas the movable part that forms the pit is wooden floor on joists. The wooden canopy over the stage has a cavity filled with mineral wool.

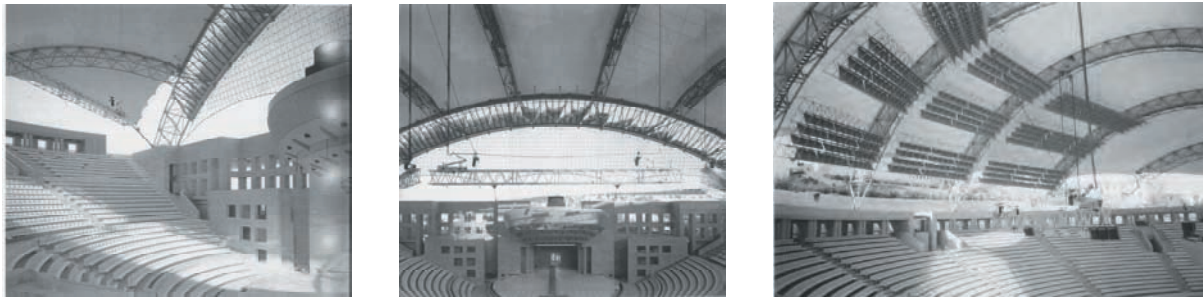
Figure 3: Interior views from Bilkent Amphitheater.

- Reorienting the fabrics hanged on acoustical bridges; the rigid roof membrane and its shape cause the primary defects including sound foci and uneven distribution of sound. The previous precaution against the reshaping of the membrane includes hanging more absorbent materials underneath. However, the sound absorption properties and the orientations of the fabrics are not satisfactory for the acoustic correction of the hall. The roof construction is slightly convex in the cross section, whereas it is closing to a perfect arc in the longitudinal section. The present acoustical fabrics are hanged on parallel to this convex section, whereas the problematic section that causes sound focuses is the opposite one. In this study, the first suggestion accordingly is hanging these absorption fabrics parallel to the concave section, as the concave surfaces focus sound, and are poor distributors of sound energy. In Figure 8, the re-arranged absorption fabrics in between the steel trusses could be observed, while Figure 3 is picturing the current condition. The uneven distribution of

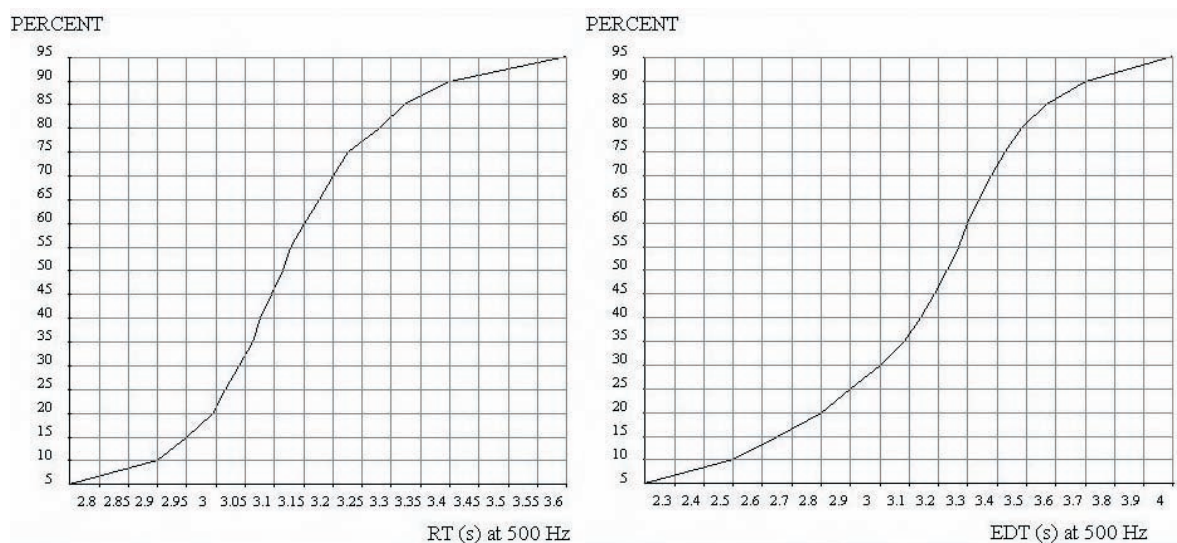
Figure 11: RT_{pres} and EDT_{pres} cumulative distribution graphs.

The uneven distribution of the RT_{pres} results is observed in the present (fully occupied) hall (see Appendix-M1). The results are ranging from 2.8 to 3.6 s according to the cumulative distribution function, whereas 3.6 s is covering the 95% of the hall for 500Hz. This value is much higher

than the required measure, especially for the speech activities. The focuses of the sound is less than the unoccupied case due to the audience absorption, however the echoes are still in disturbing amounts (Figure 11). The early decay time measures are ranging in between 2.3 to 4 s, while 95% of the values are around 4 s for 500Hz. Analyzing the map from Appendix-M1, it is found that the values are better in the front tiers especially at the mid fronts and rising towards the back tiers. Besides the focuses all over the hall, the highest values occur at the backsides. These mid frequency values for the EDT_{pres} are also higher than the maximum limit of the optimum range. Being a part of the uneven distribution of sound in the hall, the focuses that are observed all through the hall, are not the only defect. There are also dead points in compare to the live areas at the hall with reverberation times lower than 1s that are in some cases adjacent to the focus points (Figure 11).

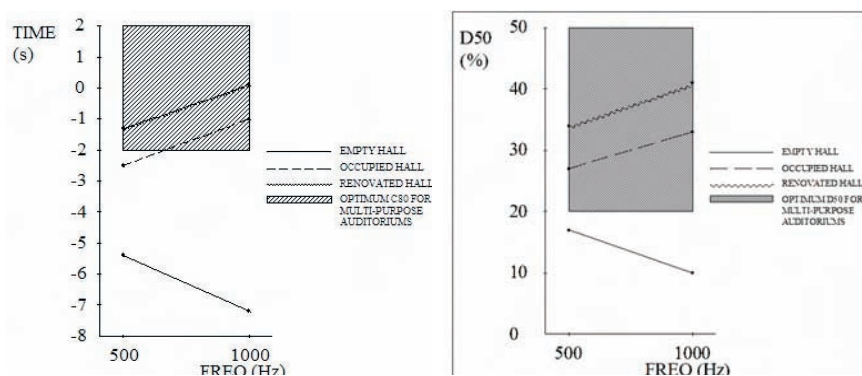
Figure 16: $C80$ and $D50$ values for empty, present (fully occupied) and renovated hall.

The clarity values of renovated hall are changed from -6 to 2.2 dB to -4 to 2.8 dB for 500 Hz. The ratio of the seats that are falling into the optimum range, especially for the music is increased significantly. The $D50_{ren}$ is ranging from % 20 to 60 in the renovated hall, while in the present hall it is from % 14 to 55 for 500 Hz. None of the seats is falling below the lower limit in the renovated hall, and it becomes especially better for the music performances. The better values for both the clarity and the definition are due to the extended canopy, which is providing increased level of early reflections (Figure 16).

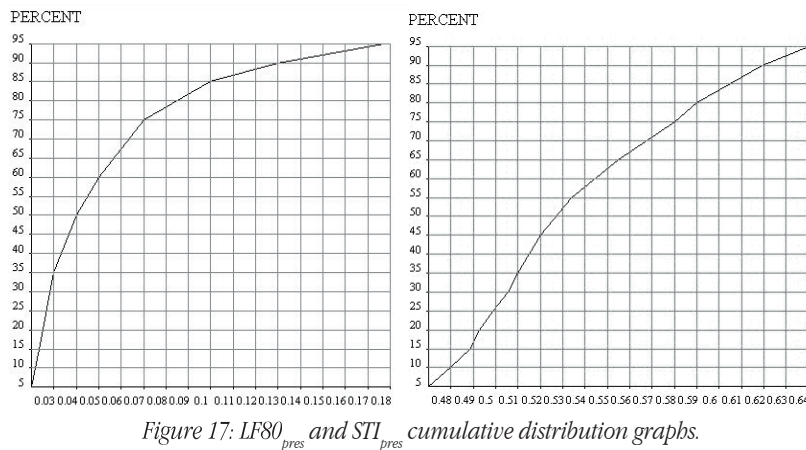
Figure 17: $LF80_{pres}$ and STI_{pres} cumulative distribution graphs.

From Figure 17, it can be observed that the $LF80_{pres}$ values are ranging in between 0.02 to 0.17 for 500 Hz. Examining the distribution maps and graphs, it is found that the $LF80_{pres}$ values of the present condition of the fully occupied hall in general is smaller than 0.15 in both frequencies. This is not sufficient for the concert halls as for other activities as well. The better places throughout the hall considering the $LF80_{pres}$ are back and front tier sides, and the back rows of the mid sides (see Appendix-M9). The STI_{pres} values are ranging from 0.48 to 0.63, which are corresponding to the fair class for the parameter in general. The results to some

extent are better than the unoccupied hall, which is again related to the audience absorption mostly at the higher frequencies (Figure 17). The maps illustrate that the value is best at the front tiers corresponding to the good class, and in very few points at the mid first row, it is classified as excellent. The sides of the mid tiers are classified as fair, and these areas are better than the centre of the mid tiers. At the back tiers the values continue to drop and in some parts, mostly at the mid parts of the last two rows, it is evaluated as bad and unacceptable for STI (see Appendix-M11) [21].

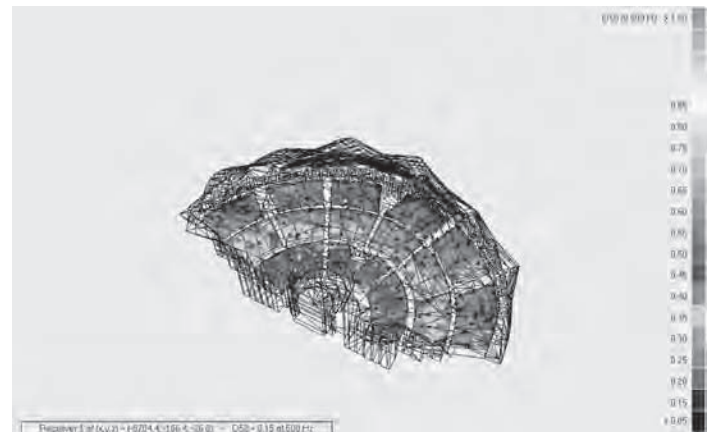
M7: Definition distribution map for 500 Hz, for the present condition of the hall.

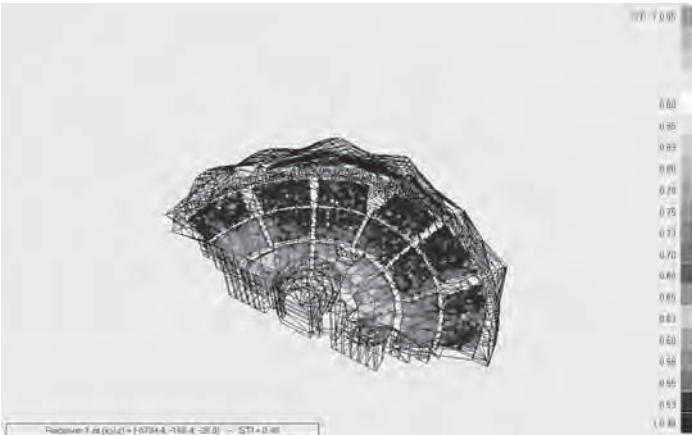
M11: Speech transmission index distribution map, for the present condition of the hall.
